Cautionary Tales

Part V Hydrogen Embrittlement Myths

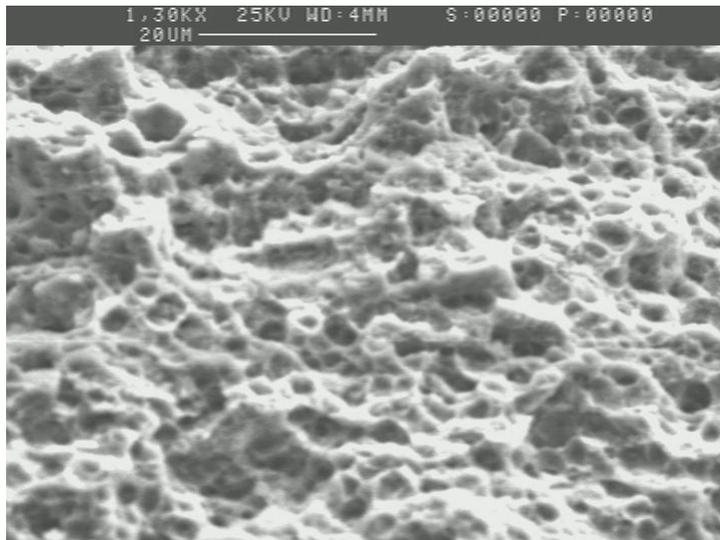
Of course *IST* can do this – we do so two or three times per month on average, for someone around the world, and about 50% of the cases we investigate are not primarily due to hydrogen embrittlement. The latest example submitted to our laboratory was found to be a simple overload failure due to excessive force applied to the part during assembly. The fracture was as shown in figure 1.

Fig 1 X 1,100
Fracture mechanism of a plated austempered CS70 spring clip. This ductile fracture is by microvoid coalescence.

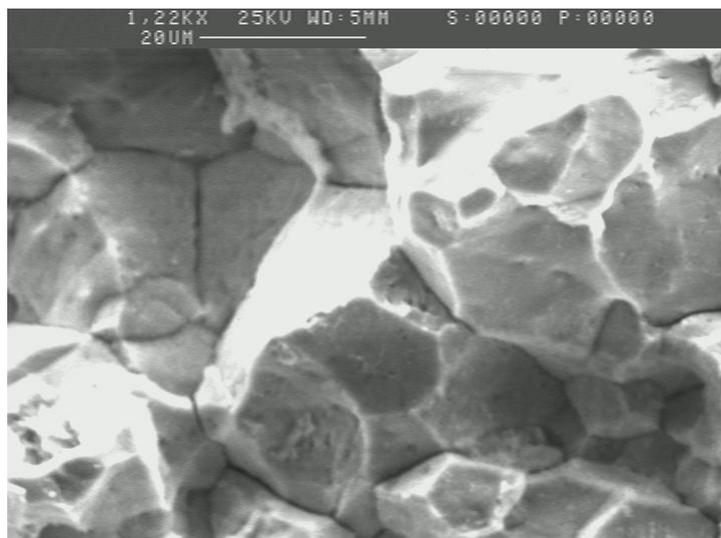
Now this is not a myth – *IST* have never found evidence that the mechanical plating process itself leaves a spring at risk. However, acid cleaning in 50% hydrochloric acid immediately prior to mechanical plating was blamed recently for the fracture appearance in figure 2.

Fig 2 X 1,100
Fracture mechanism of a mechanically plated spring clip that had been acid cleaned prior to plating. This brittle fracture mechanism is mostly intergranular.
