## Cautionary Tales Part XVII

### Employee Motivation

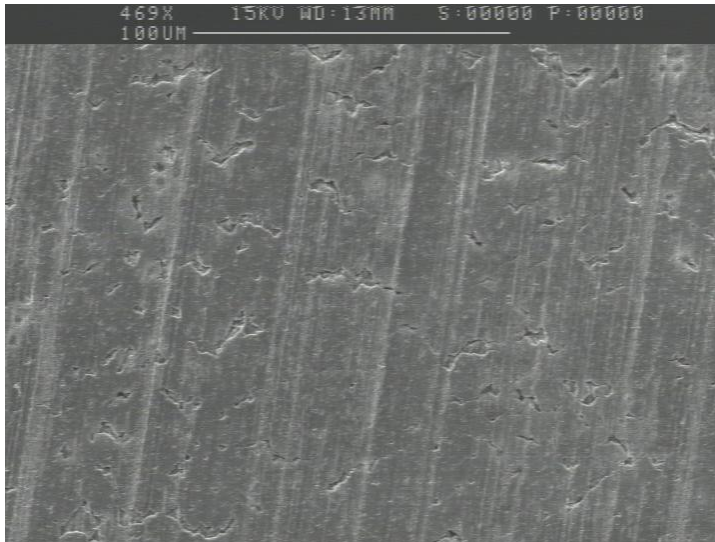
Dynacon testing of the strip showed the elastic/ plastic properties were normal, but there was excessive variation in the frictional properties of the surface and the friction was higher than usual. Further investigation revealed that the high friction was due to minute surface tears in the strip surface – the tears being invisible under a binocular microscope, but were clearly evident when examined on a scanning electron microscope, as shown in figure 1. These tears would undoubtedly have lead to the high friction, and would have been sufficient to jeopardize the life test results despite the fact that metallographic examination of these tears showed them to be very shallow.

Figure 1 Broken strip surface x 400
