Cautionary Tales Part XIX

End Coil Failure / Use of Finite Element Analysis

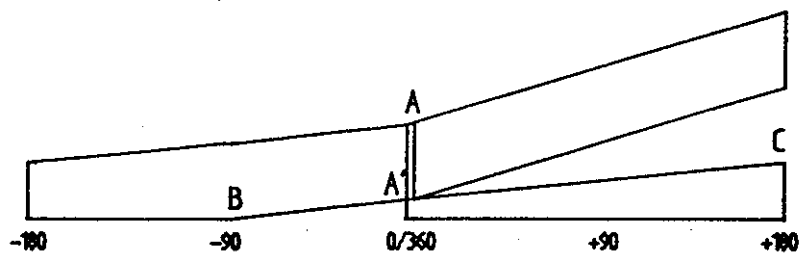
Figure 1 Spring Design One

Figure 1 represents the case when the end coil pitch transition AA' occurs at just one coil from the end tip. Figure 2 represents the transition occurring at just less than one coil from the end tip, and Figures 3 and 4 represent AA' occurring at slightly more than one coil from the end tip. The only difference between Figures 3 and 4 being that the end coil pitch is greater in Figure 4 and so there is a small gap between the end tip and the first active coil.

The finite element analysis clearly showed that abnormally high torsional and bending stresses would only occur if the end coil lay-on was as shown in Figure 2 - i.e. the pitch transition AA' occurring just before one complete turn. No abnormally high stresses occurred anywhere in the end coil region for the lay-on shown in Figures 1,3 and 4, providing that the cut-off tool did not push up a burr to dig into the first active coil.

The moral of this cautionary tale is that, to reduce the risk of end coil failures occurring in dynamic applications, end coil lay-ons similar to those shown in Figures 1,3 or 4 should be attained, and you should be very wary of accepting spring designs that have a solid stress greater than that recommended in design standards, especially if the wire section is greater than 5mm (0.200") and/or the anticipated design life is greater than 20 million cycles. The other moral is that this is the type of problem for which Finite Element Analysis is helpful, but whether the method can predict problems arising from wear has not yet been adequately studied.

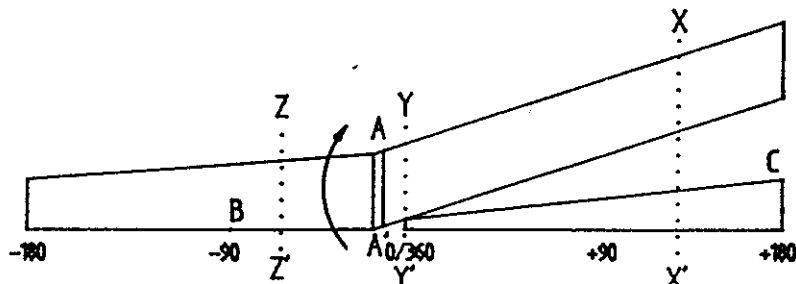
Figure 2 Spring Design Two

It is very difficult to visually identify springs with end lay-ons that correspond to that illustrated in Figure 2, especially since, in practice this transition will be more gradual and not so sharply defined as in these diagrams, and will be different at the two ends of the spring. However, when such springs are identified, observation of the spring action during loading presents some very interesting results. As the spring is loaded to approximately 50% of the available deflection, it will be observed that part

of the end coil (up to the position marked ZZ' on Figure 2) lifts off the loading platen. This action is believed to be a consequence of the first active coil of the spring pivoting about the end tip.

Unfortunately, many springs that do not show this end coil lift are prone to failure at this position, and a solution to the problem is not always easy to find. Spreading the contact between the end coil and first active coil helps as does rolling contact (rather than sudden contact) between these two surfaces, but the wear will eventually be great enough to cause fatigue at this vulnerable position – vulnerable because it cannot be shot peened and any corrosion protection will be worn away. The problem occurs most in wire sections larger than 0.200" and with SiCr and 17/7PH materials. Use of SiCrV and/or nitriding does not appear to reduce wear (abrasive, fretting or adhesive –terms that will be discussed in next month's cautionary tale) at this position.
