Cautionary Tales Part XXI Hydrogen Embrittlement again

To provide the information requested, I have now examined the spring that I was sure had failed by hydrogen embrittlement and the results are presented in a simplified format similar to that of one of *IST*'s failure analysis reports.

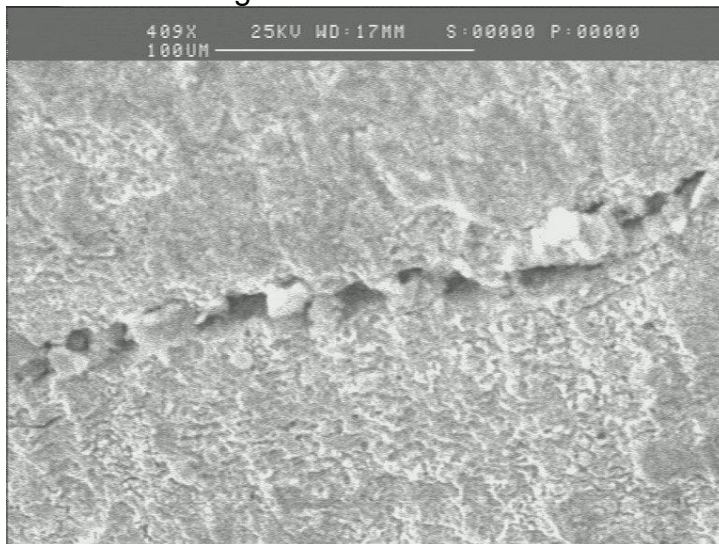
Visual examination revealed that all the fractures were within central coils, and the fracture shape was indicative of a combination of bending and torsional stress with fracture initiation at the inside surface. On a binocular microscope it could be seen that 80% of the fracture surface had been chemically blacked, and that there was another crack in one of the springs, as shown in figure 1, that was initially at about 60-70° to the wire axis.

So, how could I be so sure that the spring had failed by hydrogen embrittlement without examining it? The spring failed after a short time delay without having been used – this is characteristic of this fracture mechanism. There was another crack in one of the springs, and it was in a direction consistent with a combination of initial tension and residual bending stress. (If

Figure 1 Crack observed one coil from the fracture x 340

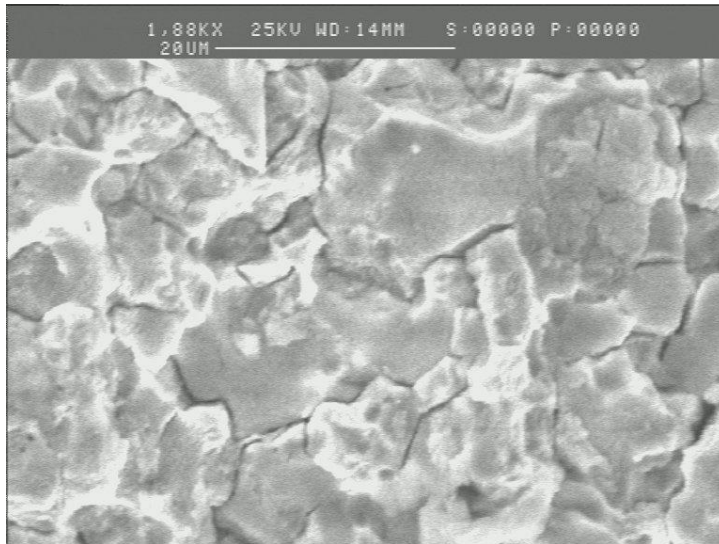
Scanning electron microscopy confirmed that the fracture was covered in chemical blacking, which was cleaned off electro-cathodically. Then the fracture mechanism was observed to be intergranular initially (figure 2), with gaping grain boundaries. Traversing across the fracture surface, away from the origin, it became gradually more ductile with quasi-cleavage and microvoid coalescence fracture (figure 3) appearing in ever increasing proportions until the final overload failure, which had no blacking on it to start with, was mostly ductile microvoid coalescence, but still with some quasi-cleavage (figure 4). To plagiarise a famous lager advert, "Only hydrogen embrittlement can do this" i.e. cause a progressively changing fracture appearance from brittle through quasi-cleavage to ductile.

Figure 2 Intergranular fracture near the origin x 1,600

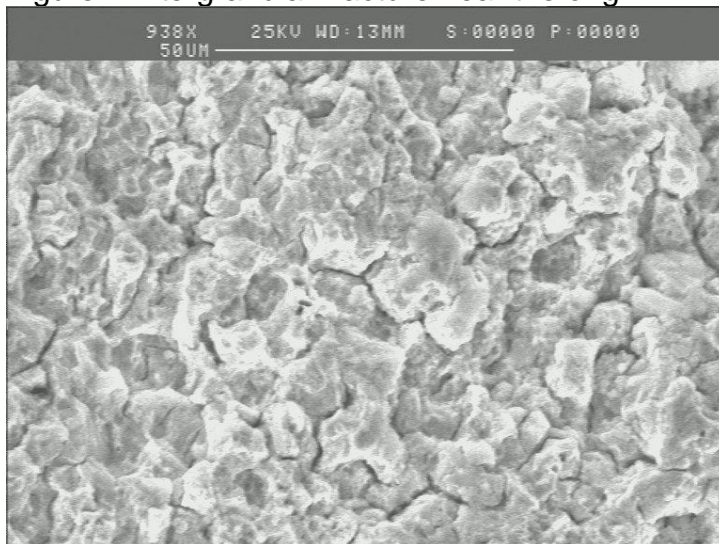
Figure 3 Appearance half way across the fracture, some intergranular, some quasi-cleavage, some microvoid coalescence x 780

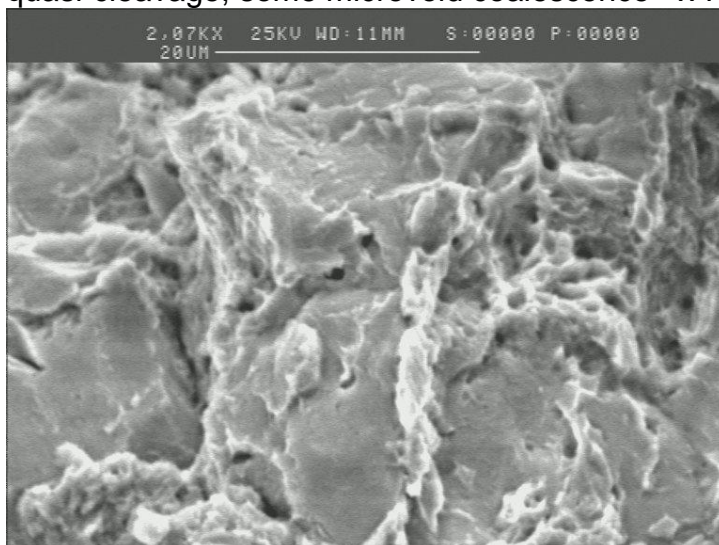
The other question raised at the start of this cautionary tale concerned the fracture mechanism. The final overload here was by a mixture of quasi-cleavage and microvoid coalescence – hydrogen was still influencing the failure. The fracture mechanism of SiCr that is broken in a tensile test is 100% microvoid coalescence. Whilst it is usually the case that this grade fails by an intergranular mechanism when embrittled by hydrogen, it is also possible that in cases of slight embrittlement that the fracture will be mostly quasi-cleavage, much as it is when drawn pearlite structures are embrittled by hydrogen. The reader who wanted this confirmation was also certain that his customer's SiCr springs had failed by hydrogen embrittlement because they had all the characteristics described herein, and the only fact that left uncertainty was the absence of intergranular fracture.

Figure 4 Quasi-cleavage and microvoid coalescence fracture at the opposite side to the origin x 1,700
