Cautionary Tale XXVI – Greatest Hits

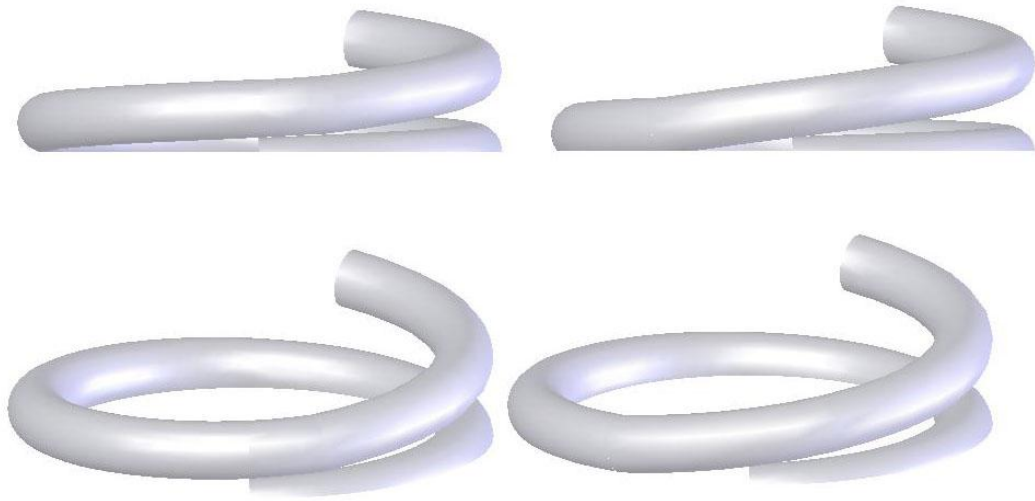
IST's solid modelling capabilities have been used to provide 3-D representation of an ideal end coil lay-on - figure 1 in cautionary Tale XIX and the case described above – figure 2 from XIX. Figure 2 shows diagrammatically the transition between the end coil and active coil pitch is still shorter than it will be in practice, but it shows the fact that a wedge type pitching tool cannot be deployed instantaneously and so there will be a transition. Furthermore setters are aware that the pitching tool affects the wire either side of the location at which it is deployed, and so this diagram shows the effect of the tool and not the position where it acts. Achieving the ideal end coil lay-on is never easy, and inspection of first off parts is difficult, but it is hoped that these diagrams explain what *IST* believe is least likely to lead to failure at this vulnerable position.

Figure 1 Solid modelling view of end coil lay-on – the one on the left is satisfactory and the one on the right is not.

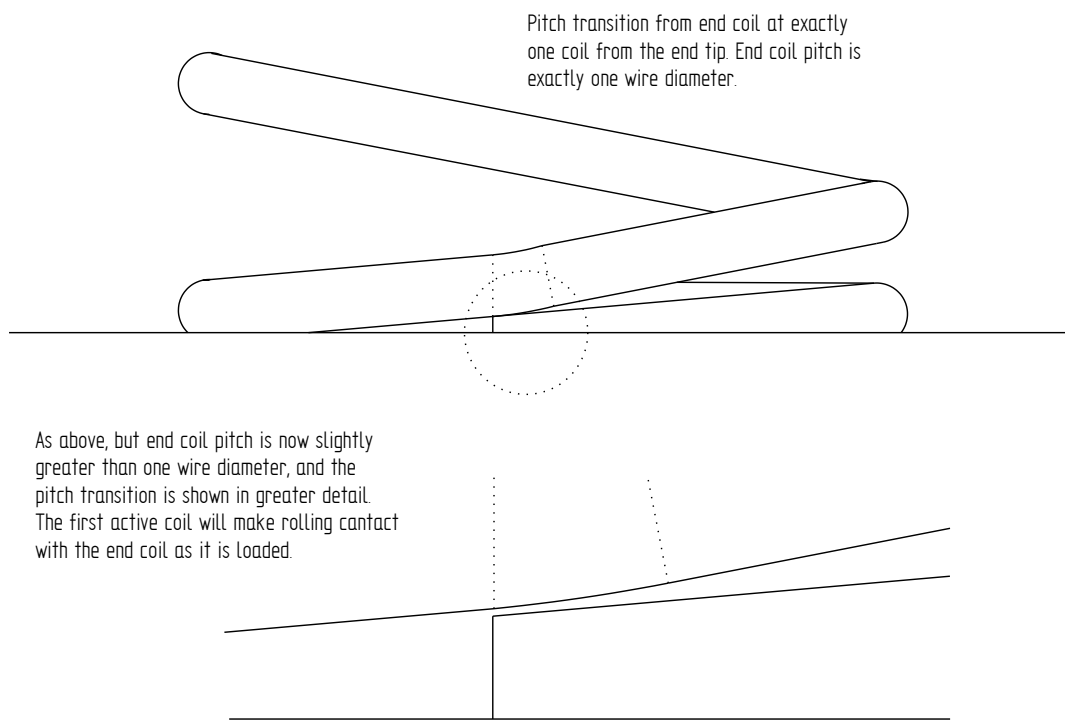
Figure 2

Tale XIX figure 2 explained how the end coil lay-on at either the first or last end of the spring can lead to very high stresses at the position where the end tip contacts the first active coil. If the active coil pitch starts before one complete end coil has been formed, and the end coil pitch is less than one wire diameter then this is likely to be the position of maximum stress in the loaded spring. In fact, there is often initial tension holding the end coil tight to the first active coil – the additional stresses consequent upon this are thought to be small, but this opinion has yet to be proven.
