Cautionary Tale XXXV Coil Cracks

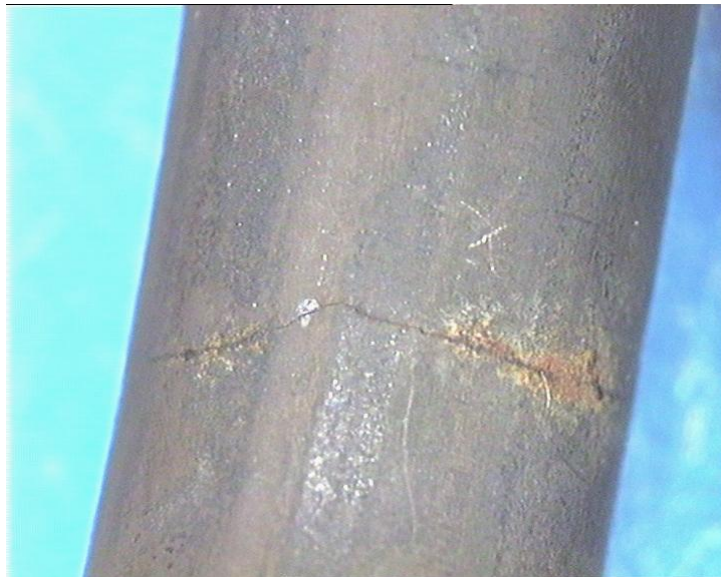
A typical coiling crack is shown in Figure 1.

The crack is transverse to the wire axis and is at the inside surface of the spring and are as likely to be found in the end coils as the active coils. In the spring shown in Figure 1 there were at least five coil cracks randomly spaced with the seven coils of the compression spring. The cracks were almost half way through the wire section - at the mouth the crack had gaped (Figure 2) and at its end had a thin layer of temper oxide (Figure 3).

Avoidance of coil cracks can only be reliably achieved by stress relieving very soon after coiling - ideally stress relieving on-line. The risk of these cracks is increased when

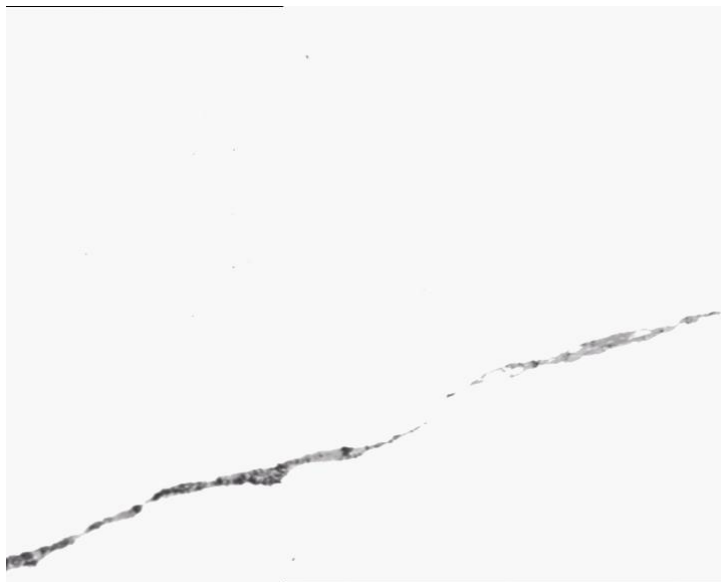
Figure 3

The existence of oxide shows that the cracks were already present before the spring was stress relieved - i.e. the crack formed after coiling, was due to the residual tensile bending stress from coiling (much greater than the residual torsional stress) and had oxidised during the stress relieving heat treatment.
