## **Cautionary Tale No. 2**

### **Hydrogen Embrittlement ~ Might your springs be at risk?**

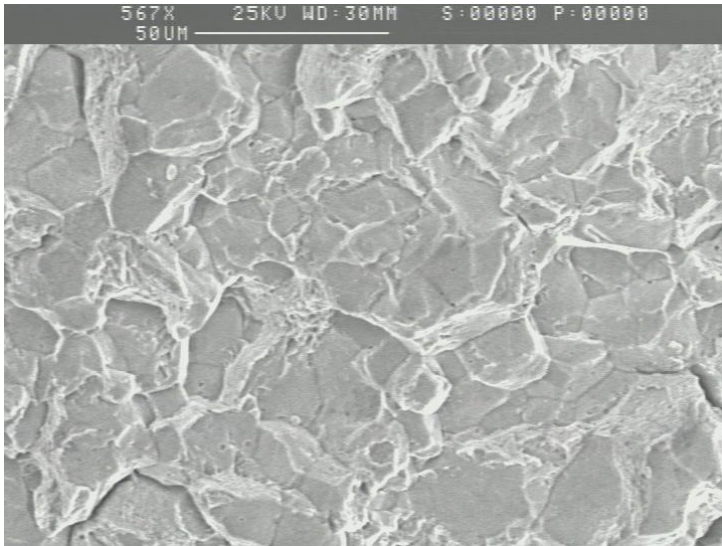
Scanning electron photograph showing an intergranular fracture due to hydrogen embrittlement – in this instance initiated by corrosion. Note the small proportion of ductile microvoid coalescence – the proportion of this ductile fracture mechanism usually increases as one moves away from the fracture origin in a hydrogen embrittlement failure. Note also the evidence of grain separation, another typical feature of this failure mechanism.
