CAUTIONARY TALE No 1

The Corrosion Resistant Properties Of Stainless Steel Springs

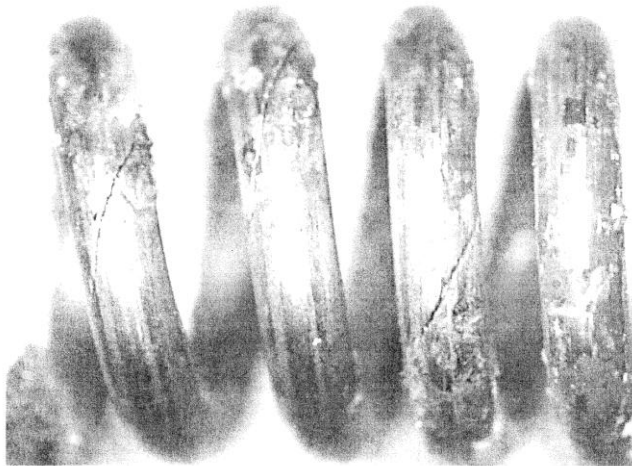
If stainless steel springs are used in an environment which contains no free oxygen (which is necessary for re-forming the oxide film), and if the oxide film is damaged in any way during service, by contact with itself or other components, or by occasional contact with an aggressive chemical, the stainless steel's corrosion resistance performance will only be like that of an unprotected carbon steel. In these

circumstances, rust is very likely, and may appear as it does in the attached photograph of a stainless steel spring that failed due to corrosion fatigue.
