## Cautionary Tales Part XX

### Wear

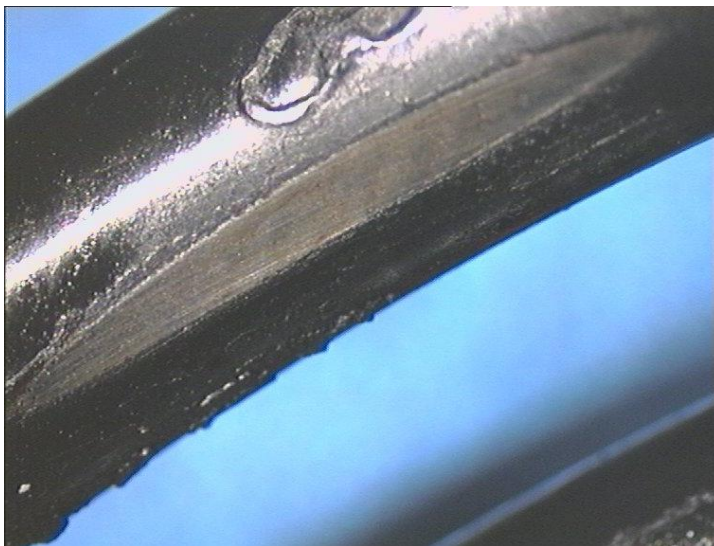
Figure 2 Abrasive wear at the inside surface of a painted torsion spring where it had made contact with its mandrel. There is little red-brown discoloration in the wear, which is fretting oxide, which has formed despite the excellent lubrication of this spring, which failed due to an ordinary fatigue mechanism after 140 thousand cycles.

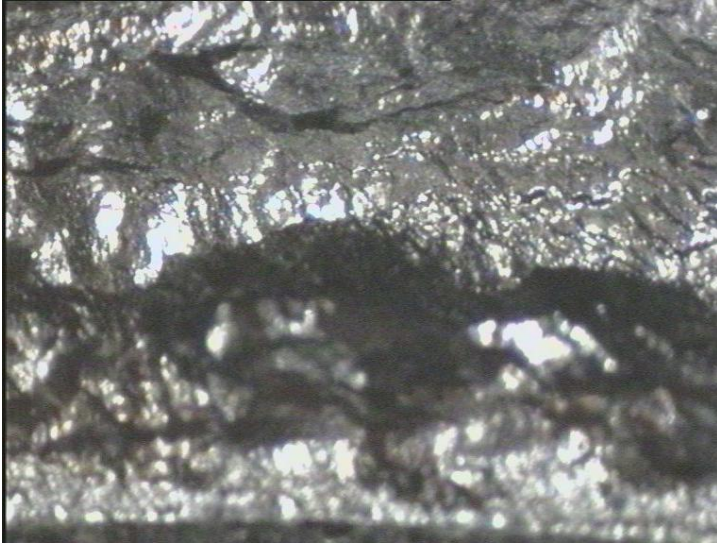
Figure 3 Severe adhesive wear that occurred between the end coil and first active coil of a spring made from 5mm diameter 17/7PH after two years of almost continuous service in a diesel engine. Note the rough topography and lumps that have been ripped from the wear surface and the cracks at the top of the photograph, which form prior to the ripping out.

Adhesive wear occurs after an abrasive wear zone has been created, and involves adhesion between the two wear surfaces. If the adhesive bond between the two surfaces is strong enough, then the wear process may lead to particles being ripped from the wear surface, a typical surface being as shown in figure 3. It is easy to imagine how this type of wear will be potentially more severe in its effect upon spring performance than abrasive or fretting wear.
