Cautionary Tale XXIX

Oxide on Stainless Steel

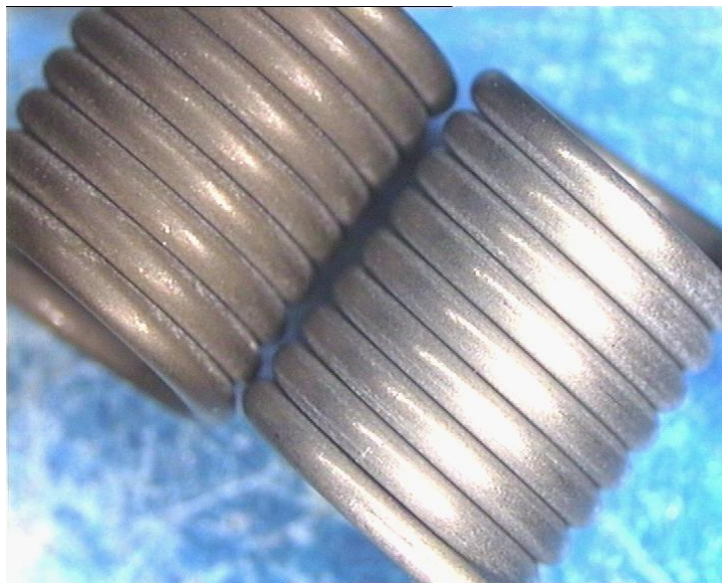
x 6

Corrosion resistance of these two springs is the same.

Notwithstanding the point of this cautionary tale is that the oxide that grows during stress relieving is not detrimental. If temperatures of 350°C (660°F) are used for stress relieving 302 stainless steel springs they go yellowy brown in colour - slight yellow at 350°C and darker at 480°C (900°F). This colour arises due to refraction of incoming light by the translucent multi-layer oxide - the colour is not real, it is a trick of light.

This yellow-brown oxide is corrosion resistant and will not harm the function of the springs. Yet, some customers still insist that they don't want their springs this colour, but still want good functionality. In these circumstances IST recommend that the oxide is cleaned off by pickling and passivating to ASTM A380. Indeed this passivation confers better corrosion resistance (as measured by hours to onset of red rust in an ASTM B117 salt spray test) to stainless steel springs than the former brown oxide. This is thought to be because the chromium oxide structure is more tightly adherent (epitaxial).
